A PUBLIC BUILDING OF THE 4th CENTURY BC ON THE PHANAGORIA ACROPOLIS*

Aleksei A. ZAVOYKIN**

Abstract: The most interesting and important discoveries made during excavations at the Phanagoria acropolis (“The Upper City” excavation) in the last decade are connected with investigation of strata and structures of the second half of the 6th–first half of the 5th centuries BC, as well as with the end of the 2nd–first half of 1st centuries BC. This can be explained primarily by the fact that the strata of other periods have been more poorly preserved or not preserved at all. Preliminary remarks are given in this paper on materials of one interesting architectural complex of the first half of 4th century BC that was constructed on the place of a public building that burned down in the mid-5th century BC. Analysis of the remaining wall foundations allows us to determine the area of the building and its planning. On this basis it is possible to assume that the building had at least two floors. Its roof was tiled. The entrance to the building, adorned with a portico with two columns, was located on the east side. The house was enclosed on three sides (west, north, and east) by paved squares

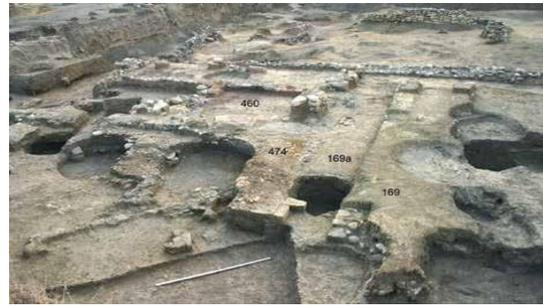
Fig. 1. General view of the complex of structures (460, 474, 169–169a) in the middle part of the Western Area. View from W to SW.

This stone foundation served as the base for construction made of sterile yellow clay (its traced array is about half a meter thick—Figs. 1 and 41). The fact that no signs of masonry of adobe bricks or pieces of one were found here is to be especially emphasized. And this is very important to consider since there was no technological need for leveling the surface of the foundation in order to put on such a thick layer of clay.⁸¹

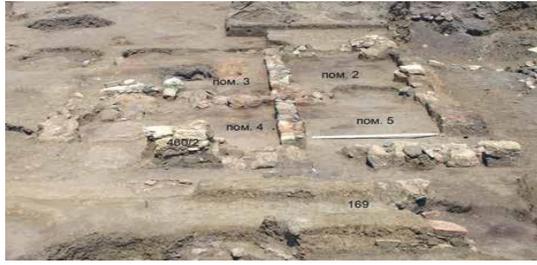
Fig. 2. General view from the south to the remains of building 460. View from the south.

The stone base of wall 460/3, separating the interior space into western and eastern “compartments,” is fundamentally different from the above-described foundations (Figs. 2 and 10). Its masonry, abutting the ends of the southern and northern exterior walls, has a length of 7.2 m, and a thickness of 0.35 m. The masonry, double-plated without backfill, was formed of one row of small unmodified “flagstones,” limestone, and small flattened cobbles. The upper surface of the masonry was preserved in original form.¹³ The base of the masonry lies at approximately 0.5 m above the base of the foundation of the outer south wall (460/2). The small width of the stone base of the wall inevitably leads to the conclusion that it was formed of mudbricks cut in half, since brick of the standard for Phanagoria dimensions (0.48–0.50 x 0.38–0.40 m)¹⁴ could not have been used here even with the stipulation of laying it

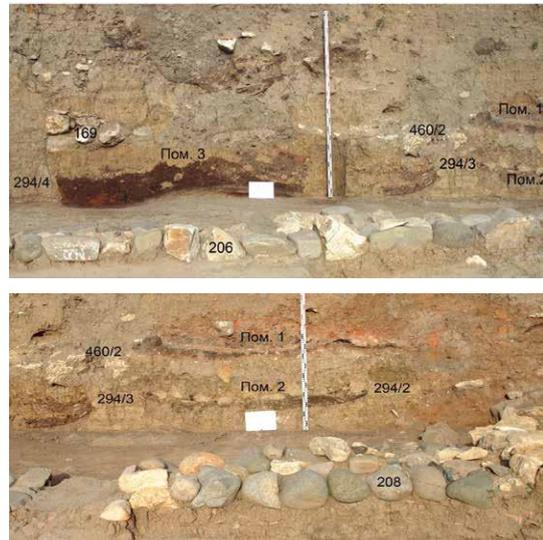
Fig. 4. Buildings 294 and 460, stratigraphic cross section (along the western border of the Central Area).

The structure of the destruction stratum on the floor can be traced very clearly (Figs. 4; 23:2, 3; 24). Directly on the floor lies a thin layer of plaster fallen from the wall, smashed into a multitude of small pieces (it was burned to an ashy-gray color as a result of the action of the fire). Then, there is the layer of the remains of the burned wooden structure of the ceiling (well expressed in the southern and northern parts of the room). Above, in the southern and middle part of the room is rubble of tiles (in the south it melted, slagged as a result of high temperature; Fig. 24: 2); in the northern part of the room pieces of tiles were absent. Finally, above the remains of the collapsed roof are the ruins of the fallen mud-brick walls, in the northern half burned to a brick-red color.

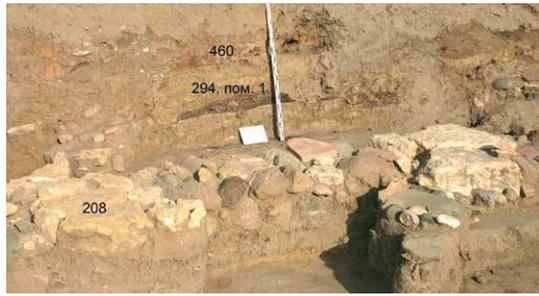
Fig. 5. Masonry of the foundation 208 and layers of destroyed buildings 294 (below) and 460 (above).

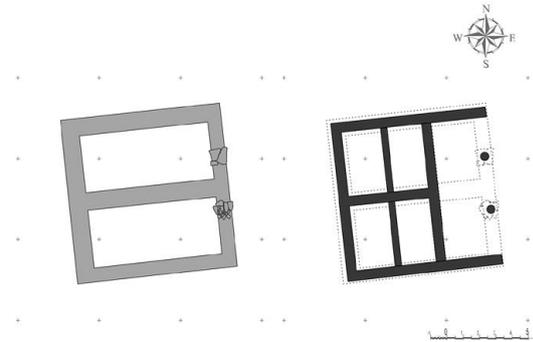
Fig. 6. Stages of construction of building 460 and reconstruction of its plan: a—foundations of the bearing walls; b—plan at the level of the socles.

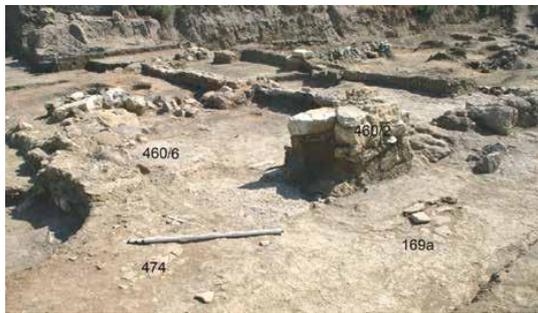
Fig. 8. General view of building 460 from the outer SW corner.

Wall foundations. The surface parts of the outer walls were almost absent. The only exception is a small area at the south wall (460/2) that was preserved to a length of 6.15 m (Figs. 8 and 9). The most well-preserved part of this wall is adjacent to the SW corner of the building. Here the wall is represented by three rows of stones to a height of 0.65 m.⁶ The thickness of the wall (the socle) is 0.6 m and its foundation—0.8–0.85 m. It is formed of stones of Kerch limestone (shell rock) of various dimensions, including rather large blocks and small unformed stones filling the gaps between the larger ones.⁷ In the masonry of the foundation the stones have no traces of modification "in place," whereas in the socle roughly chipped blocks were hewn on

Of the remaining outer walls and partitioning wall 460/5, only their foundations remained. However, a huge flat stone⁸ was preserved *in situ* at the SW corner of the structure (Figs. 8 and 15), while all the remaining corners of the building were destroyed by later pits. Adjoining the corner stone on the north was the same large flat stone⁹ of the western exterior wall

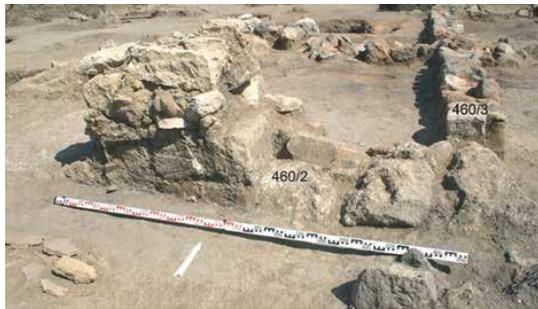
Fig. 9. Western part of the south wall (460/2): foundation and socle of the masonry. View from the SE.

two facades (Fig. 9). The masonry of the wall is irregular, without respect to the rows. The lower stones of the foundation are represented chiefly by roughly flaked large blocks placed in one row transverse to the masonry. There is no doubt that the upper part of the wall (as all the others) was constructed from raw mud bricks, which by the long side (0.48–0.50 m) were placed transverse to the masonry. (The thick rubble of adobe material burned in the fire filled the space within the rooms; see below).

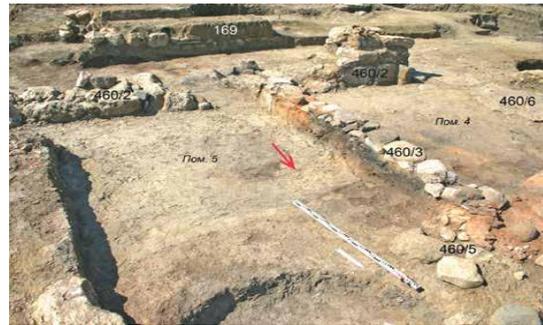
Fig. 10. The southern part of building 460, below the layer of conflagration. The arrow indicates the masonry of wall 294/2. View from the NE.

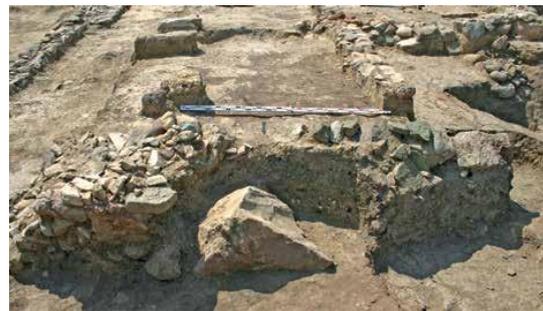
Fig. 11. Remains of the north wall (460/4) of the building. View from the north.

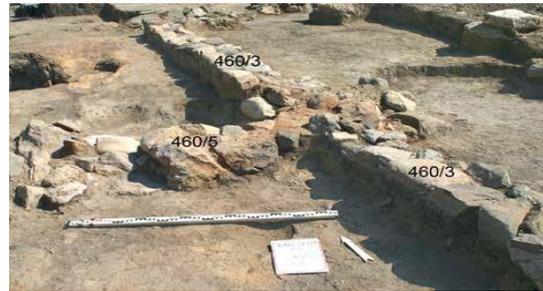
Fig. 13. Articulation of the masonry of the foundations of walls 460/3 and 5. View from the SW.

It is necessary to focus attention on the place where the stone masonry of wall 460/3 “articulates” with the foundation of partitioning wall 460/5 (Fig. 13). Strictly speaking, it is impossible to confidently identify the structure of the masonry where the masonry of 460/3 intersects foundation 460/5. Therefore, it seems more correct to speak of two segments of wall 460/3—northern (a) and southern (b), or even of two separate walls, with their ends (southern and northern, respectively) resting against wall 460/5.

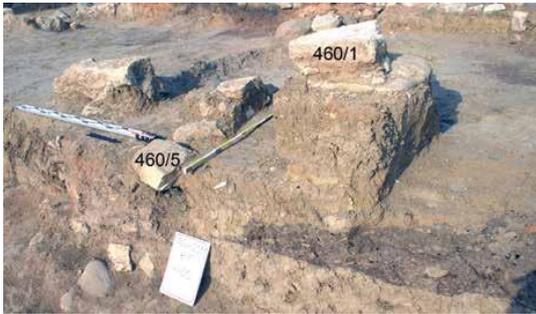
Fig. 14. Remains of the eastern part of the foundation of wall 460/5 (at the edge of the Central and Western areas). View from the NE.

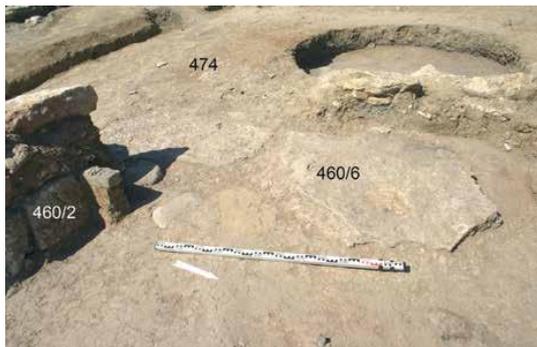
Fig. 15. Inner SW corner of room 5. View from the NE.

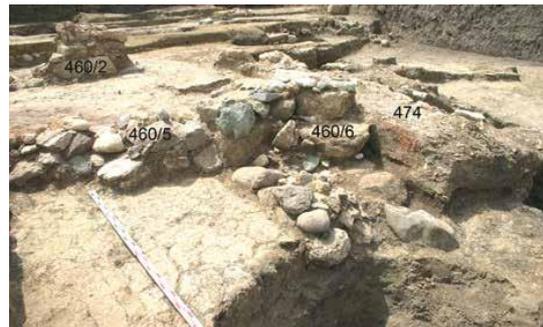
Fig. 16. Interior of the SW corner of room 3. View from the NNE.

(460/6), while farther to the north the masonry of its foundation drops (toward the slope of the hill) and changes in character (Fig. 16). Actually, regarding the northern part of the foundation of this wall, as well as the northern wall of the building (460/4) and the preserved part of the foundation of the partitioning wall separating rooms in the north and south sectors (460/5), it is difficult to speak of as masonry, since they are made up of different sizes of stones of various kinds haphazardly scattered and not showing signs of rows or faces. The strong impression is formed that the stones of these foundations filled trenches dug before their placement. A noticeable feature of these foundations is the presence in them of large unmodified chunks of heavy sandstone.¹⁰

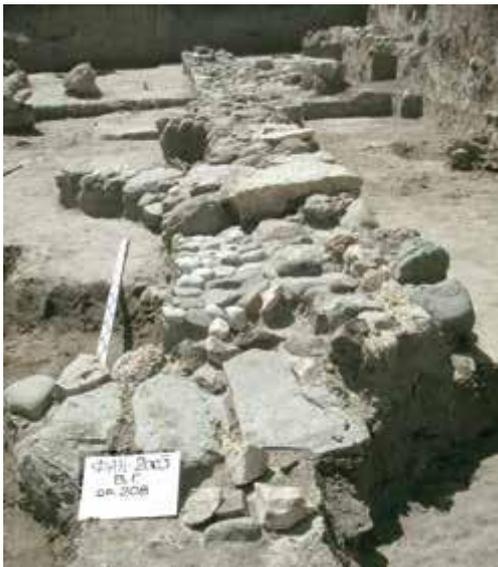
Fig. 18. Foundation 208. View from the north.

The eastern foundation (208) of the building, excavated in 2005, deserves a special word (Figs. 17–19). I will quote (with small ellipsis) its description in the report.

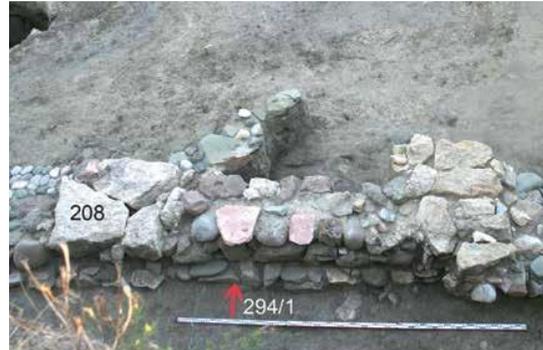
Fig. 19. The same (below the western face is seen the edge of masonry 294/1, indicated by an arrow). View from the west.

⁵ The stones of the foundation of the eastern wall (208) lie on the stone foundation of wall 294/1 (Figs. 19 and 20); the southern wall (460/2) is on the raw brick partitioning wall 294/3 (Fig. 4: 1 and 2); the partitioning wall 460/3—on the western raw brick wall 294/6; and the northern wall (460/4)—on the outer northern wall 294/4.

The bottom stones of masonry 208 abut the stone foundation (294/1) of the previous structure (Figs. 19 and 20). Masonry of unmodified stone was formed, chiefly of rather large cobbles (“cobblestones”) and limestone; smaller stones placed along the unmodified face of the masonry fill the gaps between the large ones.

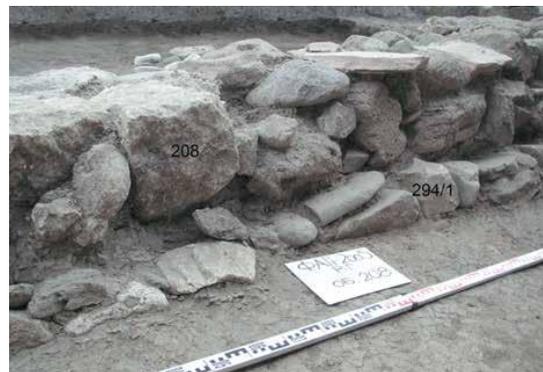
Fig. 20. Foundation 208, detail. View from the NW.

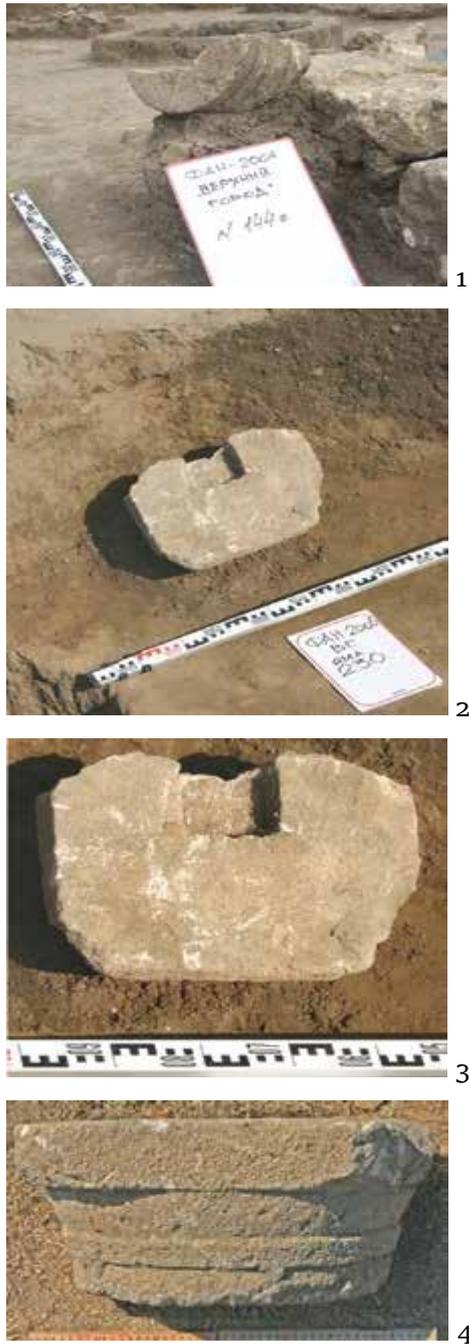
Fig. 21. Fragments of Doric capitals of columns. 1—next to the foundation of the building 144; 2–4—in pit 230.

Discussions about the order of the eastern facade of building 460 are reminiscent of two finds made directly east of foundation 208. One of them was discovered in 2004 near the southern (interior) face of foundation wall 144d²⁴ (Fig. 21: 1). Half of a Doric capital of a column was found here, carved from Kerch limestone. The other half of the same (or, in any case, analogous) architectural feature was found in 2006 near the bottom of pit 320 which was opened in the same place (Fig. 21: 2-4). A square abacus (0.48 x 0.48 m) 8 cm in height.²⁵ A deep square hole (8 x 8 x 6 cm)

for attachment was carved on the upper plane. The ekhin was poorly profiled, the truncated conical, the entasis practically invisible (diameter above—0.43 m, below—0.39 m, height—6 cm). It is constricted by a relief belt (“strap”)²⁶ 3.5 cm wide. The smooth cylindrical neck has a diameter of 0.37 m.²⁷ The total height of the capital is 0.22 m, the depth of the profile—4 cm.²⁸

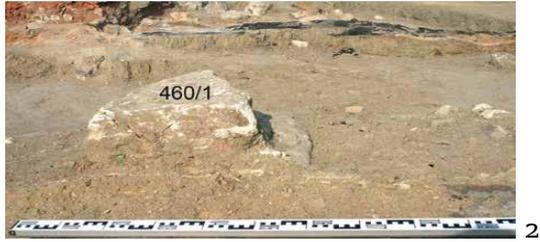
Fig. 22. Plaster *in situ* at the eastern face of wall 460/1. 1-view from the top; 2-view from the east (in the background, burned bricks in room 4).

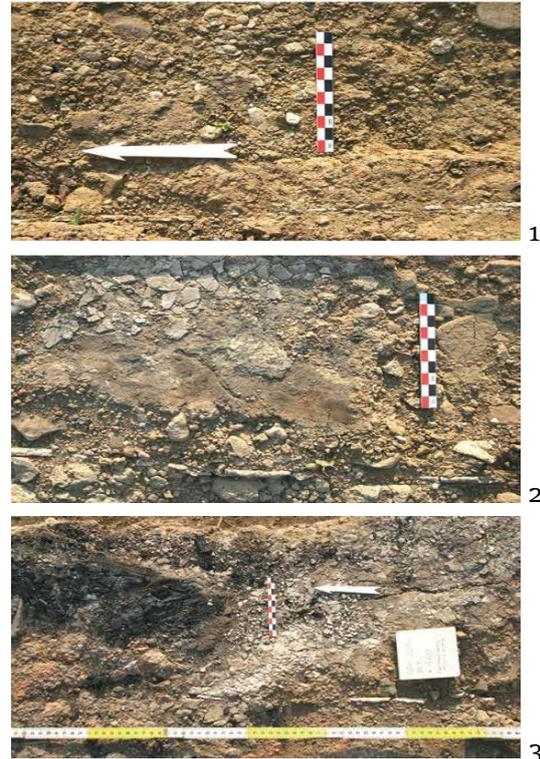
Fig. 23. Floors of room 1 (detail). 1—plaster *in situ* and pebble paving; 2—plaster *in situ* and fallen to the floor; 3—plaster fallen from the wall and the remains of burned wood from the structure of the ceiling.

The floors, ceilings, walls (structure of the fill). The problem that was raised, which has not received a satisfactory explanation, prompts one to the question of floors in the rooms. And we begin examination of the question with the most understandable. As was already said, to the eastern face of wall 460/1 “adjoins” a thin (0.5–0.7 cm) strip of vertically standing plaster (Fig. 22). This strip is the clear western boundary of the floor that covered the area of room 1. At the base of the floor lies a sand-clay layer (to 2–3 cm thick), in which small (0.3–1.0 cm) sea pebbles are abundantly mixed, the upper horizon of which forms a compact surface (Fig. 23: 1).³⁶

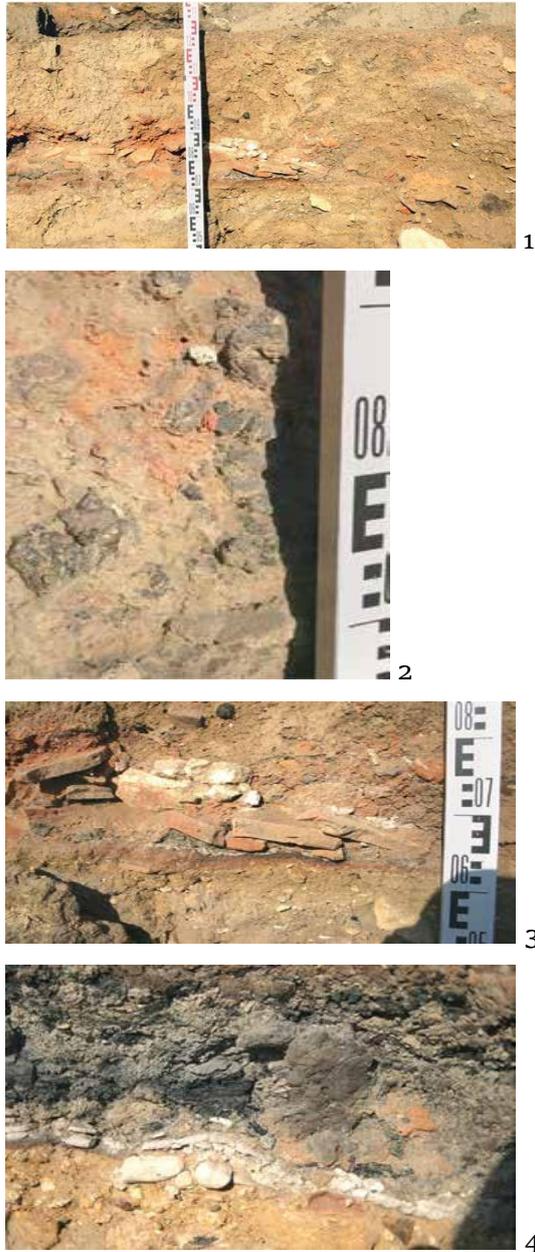
Fig. 24. The layers of destruction in room 1 (western boundary of the Central Area): 1—south half of the room; 2—tiles slagged in the fire; 3—tile roof collapse on the pebble floor; 4—pattern of destruction (1—pebble floor; 2—fallen plaster; 3—remains of wooden parts the ceiling).

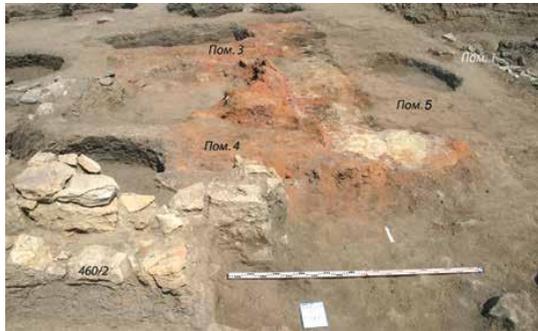
Fig. 25. Layer of burned area in the interior rooms. View from the south.

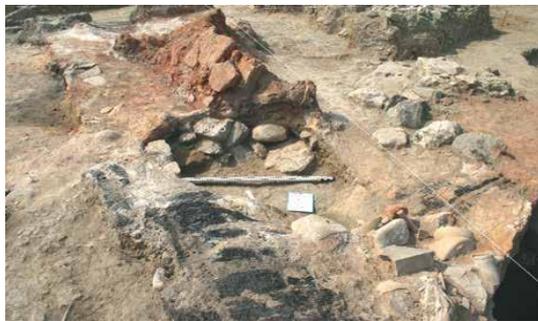
Fig. 26. The same. In the foreground (room 3) the remains of a burned wooden structure and the collapse of pottery over it, in the back (room 4)—rubble of burned bricks. View from the north.

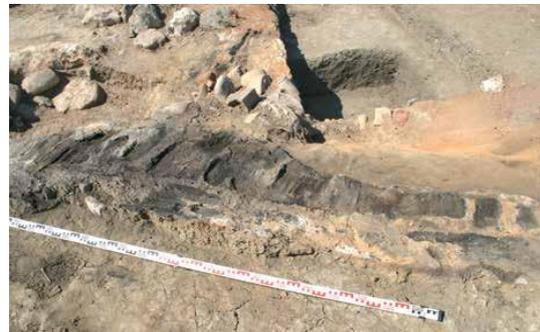
Fig. 29. Imprints of burned boards in clay (after removal of wood charcoal). View NE.

It is very important that the wooden structure was located at its eastern edge above the stones of foundation 460/3, on top of layer of compact gray clay that lay directly on the masonry. Deep imprints of the boards were preserved in the clay (Fig. 29).⁴² The boards of the structure had a pronounced slope to the west, toward a depression in the form of a trench (Figs. 28 and 31) that passed parallel to wall 460/3, in line with the trench in room 4 (foundation 460/5 separates them). On the bridge between the pits (48 and 435), where the

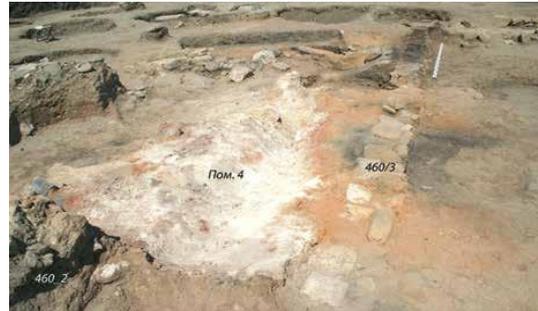
Fig. 30. The surface in the interior rooms (3 and 4) after the removal of the rubble of burned mud bricks. View from the SSE.

The situation discovered in the western pair of rooms (3 and 4), in which traces of the action of a conflagration can be seen especially clearly, was different. Room 4 turned out to be completely littered with walls burned orange-red and in places calcined pieces and even whole bricks were preserved (Figs. 25 and 26).³⁹ In the northern part of the shambles, close to wall 460/5, lay bricks on edge in three rows, at an angle to the horizon (the tilt of their plane from west to east about 45°).⁴⁰ Under the rubble of burned mud bricks, and on top of stone masonry 460/3, a thin ashy-white crumbly layer was located—the burned remains of some organic (?) material in the form of powder (Figs. 30 and

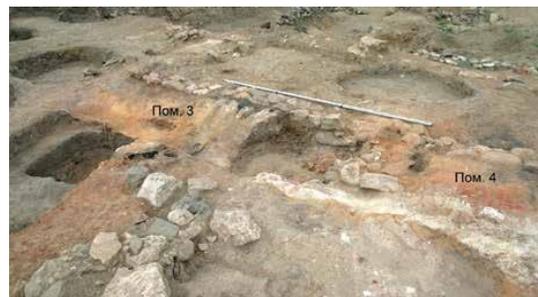
Fig. 31. General view of rooms 3 and 4 after removal of the burned layer. View from the SW.

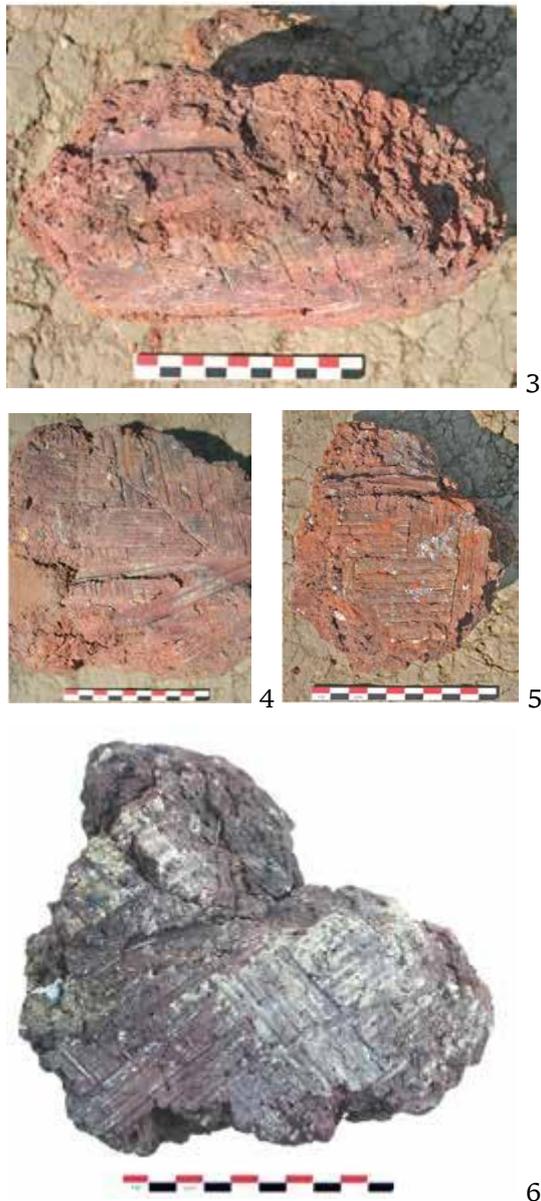
Fig. 33. Clay coating with traces of plant materials from the burned layer in the rooms of building 46o.

Rather often with excavations, especially of buildings perished in a fire, are encountered fragments of burned clay bearing imprints of thatch (Fig. 33: 1–3). This affordable and convenient material was also widely used in the northern Black Sea region from earliest times.⁴⁸ Thatching,

material in the ceilings of building 46o. It pays to note only two small features. It can be seen on one of the imprints that the thatching could have been connected in bundles using twisted rope (Fig. 33: 2).⁵³ On another piece of burnt clay, the imprint of thatching (on the lateral surface of the piece) is combined with an imprint of another raw plant material (Fig. 33: 3 and 4).

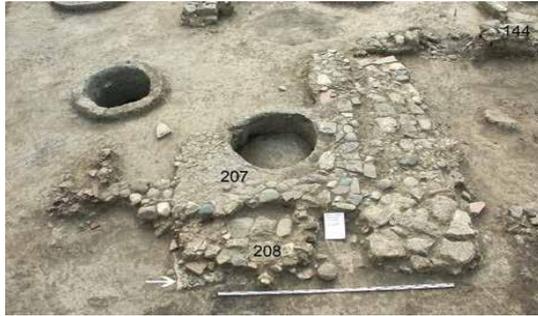
Fig. 34. Pavement 207 and the upper part of foundation 208 (arrow indicates the edge of the stone of the northern support platform for a column). View from the west.

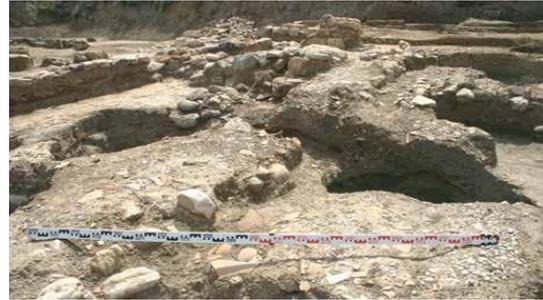
Fig. 35. Pavement 474, the area adjoining building 460. View from the NNW.

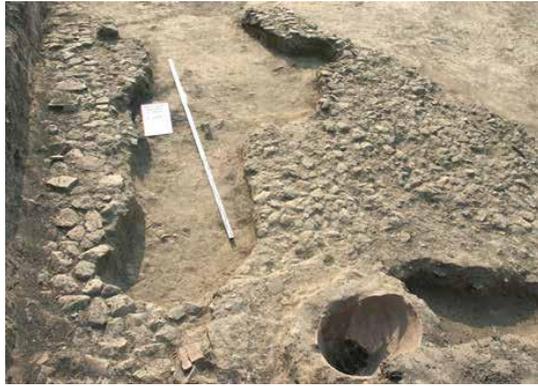
Fig. 38. Pavement 209. View from the west.

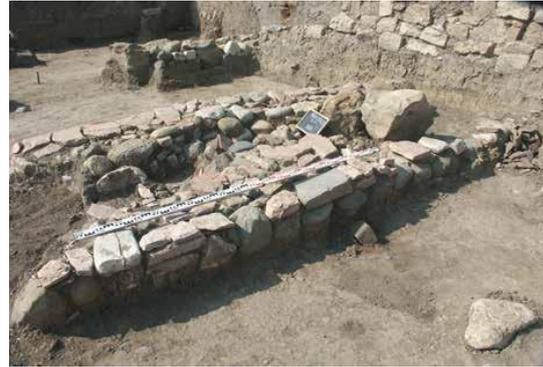
Fig. 39. Foundation of the feature 169 (Central Area). View from the NE.

horizon⁷¹ as that of the building. The structural stone, of which the foundation was composed, is generally similar to the material in the foundation of building 460, including the large piece of dense sandstone that was used as a corner stone (SW corner).

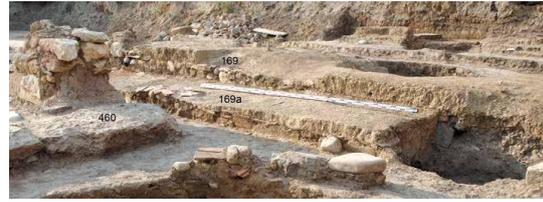
Fig. 41. Feature 169–169a (Western Area). View from the NW.

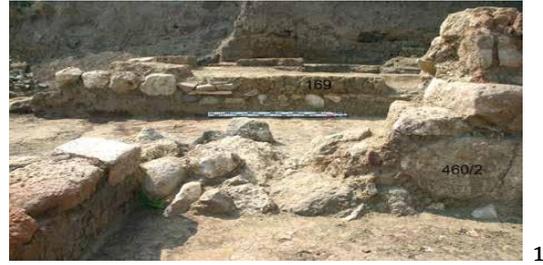
Fig. 42. Feature 169, faces of the middle part of the foundation: 1—north face (and SE corner of room 4 of building 460); 2—south face.

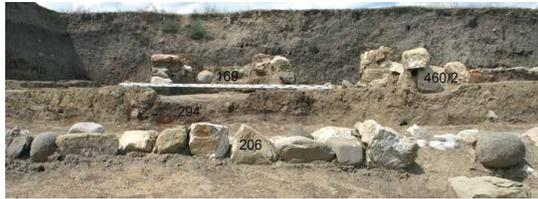
Fig. 43. Feature 169 and the south part of building 460 in profile (along the western edge of the Central Area). View from the east.

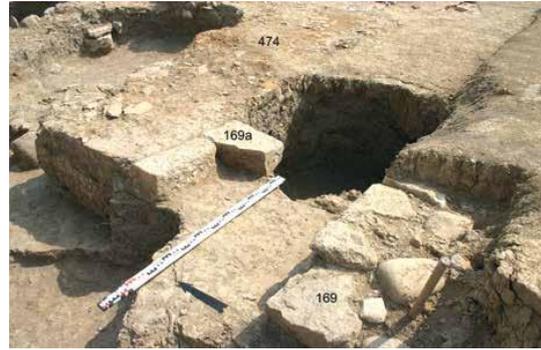
Fig. 44. Western part of feature 169–169a (cut through by the corner of the 19th century trench) and pavement 474. View from the SW.

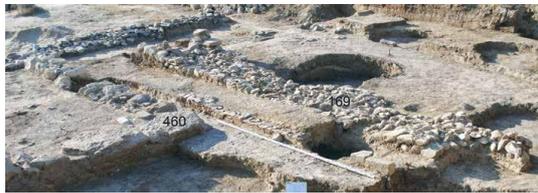
Fig. 45. The stone foundation of feature 169. General view from the NW.

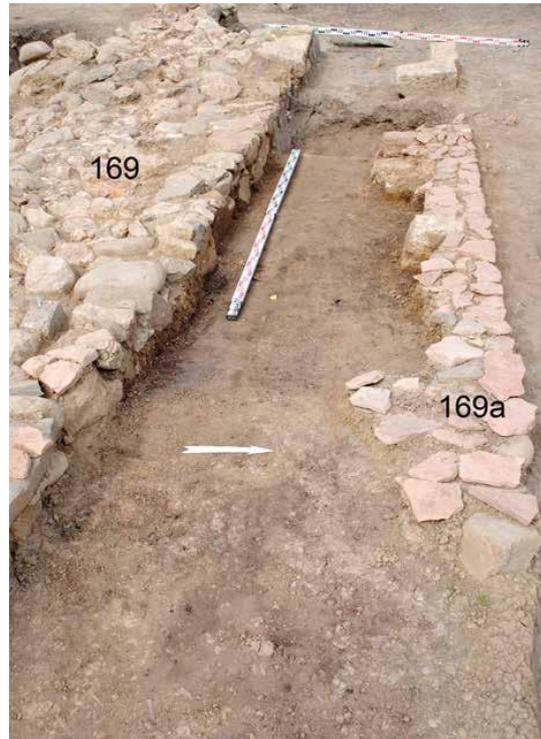
Fig. 46. Stone foundations of features 169–169a. View from the east.

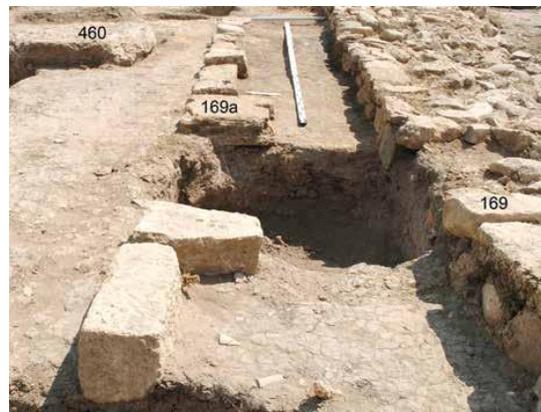
Fig. 47. Stone foundations of features 169–169a. View from the west.
